Crack Detection in Cast Stainless Steel Valve Utilizing Nonlinear Acoustics

K. C. E. HALLER¹, S. A. K. ANDERSSON¹ and H. MARTINSEN²

A study of crack detection in cast stainless steel utilizing a nonlinear acoustic method is reported in this work. The technique is briefly described, and is exemplified by carrying out a fingerprint measurement.

The specimen was a test block made of a valve provided from Ringhals AB which was cut in three pieces. One of these pieces is evaluated in un-cracked condition as initial reference. Subsequently, cracks are introduced and new evaluations are made.

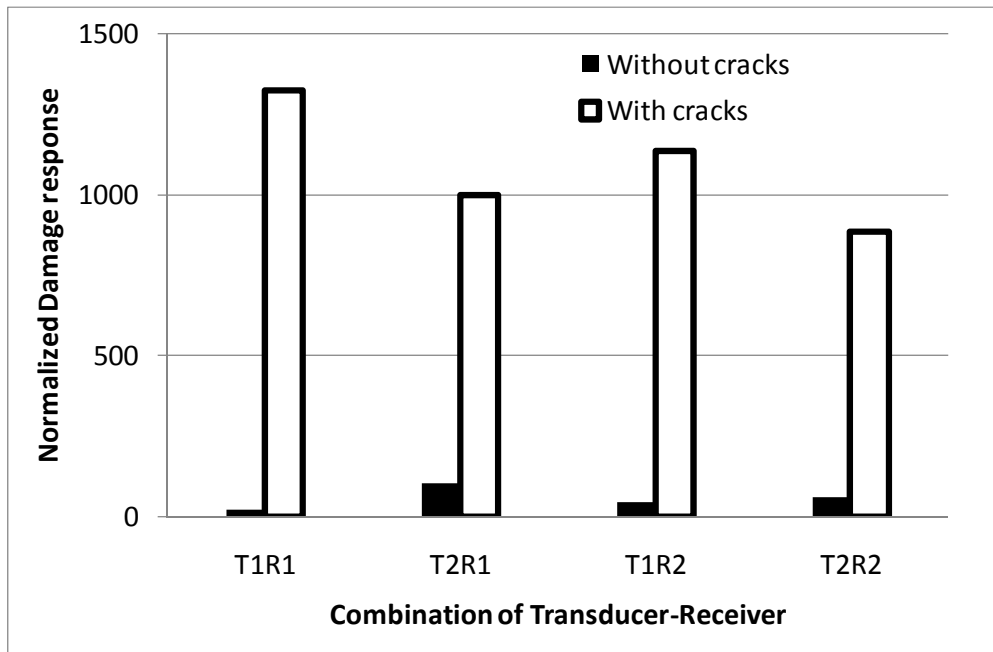
Figure 4. Fingerprint result for all transducer and receiver combinations.

The result produced utilizing the automatic method is shown in figure 4. The notation in the graphs follows the example T1R1, referring to the positions of the transducer (T1) and the receiver (R1). The graphs show the results for all the combinations of each transducer combined to each receiver. The bars filled with black are the results from the initial measurement, without the cracks introduced. The bars filled with white are the result from the measurement when cracks are introduced.

As can be seen, no matter which combination of transducer and receiver used for this measurement a clear indication of the presence of cracks is given. Introducing cracks into this valve gave at least 15 times larger indication value which is a clear indication of damage.

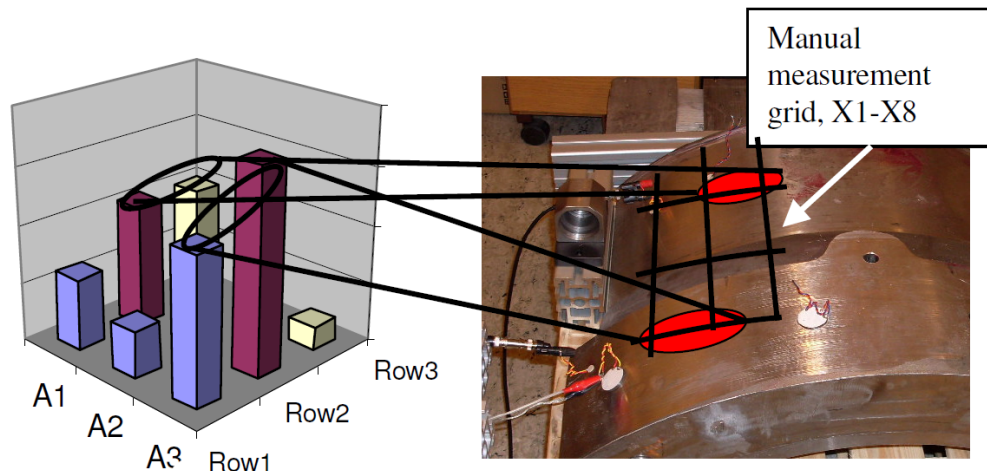
Figure 5. Localization of the damage.

Using a manual technique all the transducer and receiver combination were obtained. By mapping the damage response in relation to each other in space, the physical location of the damage can be determined. This is presented in figure 5. The explanation legend is presented in table 1.

The graph to the left in figure 5 shows how the damage response is distributed in the valve after the cracks are introduced. The picture to the right in figure 5 shows where the damage is mapped from the damage response to the real valve. These locations were verified by Ringhals AB as being the correct positions.
