35-Year Structural Monitoring of a Prestressed-Concrete Pressurized Wind Tunnel

ABSTRACT

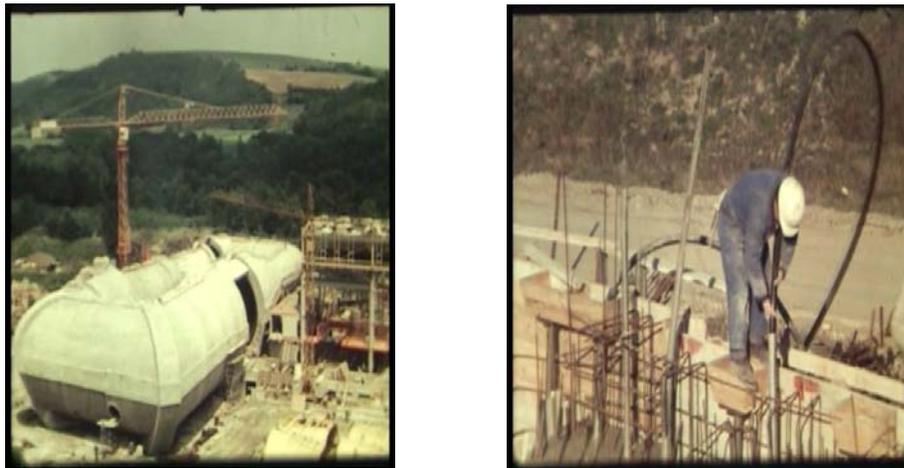
Figure 1. Construction (left: Wind-Tunnel overview, right: post-tension setup)

The aerodynamic circuit is made of prestressed concrete, which was a major innovation for a pressurized wind tunnel (1) in the 70's. Coyne and Bellier company designed the wind tunnel, based on its large experience within prestressed concrete structures (reservoirs, reactor vessels, etc.)

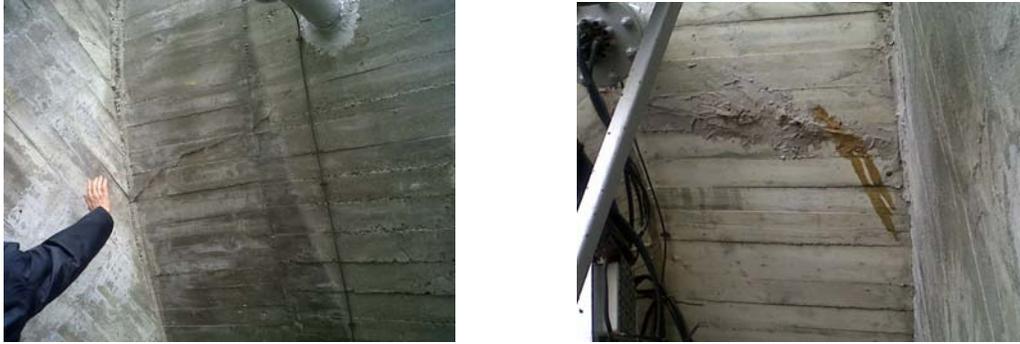
Figure 2. Visible microcracks causing air leaks when pressurizing (left: resin repair).

After more than 25 years of operation, few microcracks occurred and became visible on the outside tunnel surface. As a consequence air leaks is hindering nominal pressure to be reached inside the wind-tunnel.
