Crack Detection in Cast Stainless Steel Valve Utilizing Nonlinear Acoustics

K. C. E. HALLER¹, S. A. K. ANDERSSON¹ and H. MARTINSEN²

A study of crack detection in cast stainless steel utilizing a nonlinear acoustic method is reported in this work. The technique is briefly described, and is exemplified by carrying out a fingerprint measurement.

The specimen was a test block made of a valve provided from Ringhals AB which was cut in three pieces. One of these pieces is evaluated in un-cracked condition as initial reference. Subsequently, cracks are introduced and new evaluations are made.

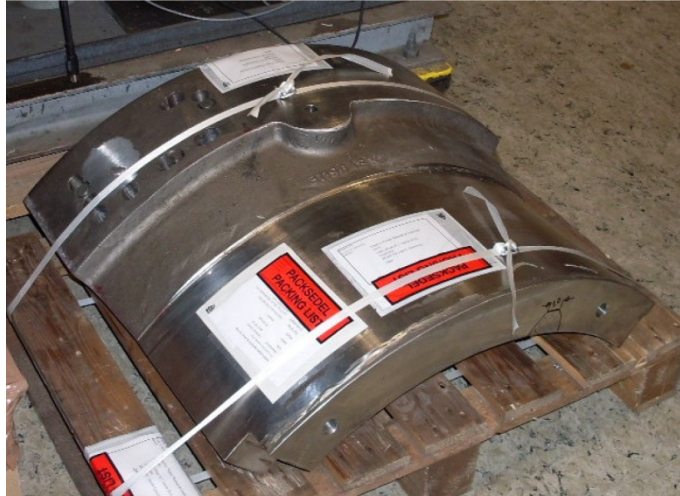
Figure 1. The 1/3 valve on pallet.

The introduced damage consisted of two cracks in two different locations inside the valve. The cracks had the size of 50mm and 70mm respectively and were located in the middle of the valve's thickness. Both cracks were decided to be located in the right half of the valve as shown in figure 1 and in the left half as shown in figure 5. The locations in this half of the valve were unknown prior to this fingerprint measurement.
