Guided Waves-Based Damage Detection in Aircraft Component

P. MALINOWSKI, T. WANDOWSKI and W. OSTACHOWICZ

ABSTRACT

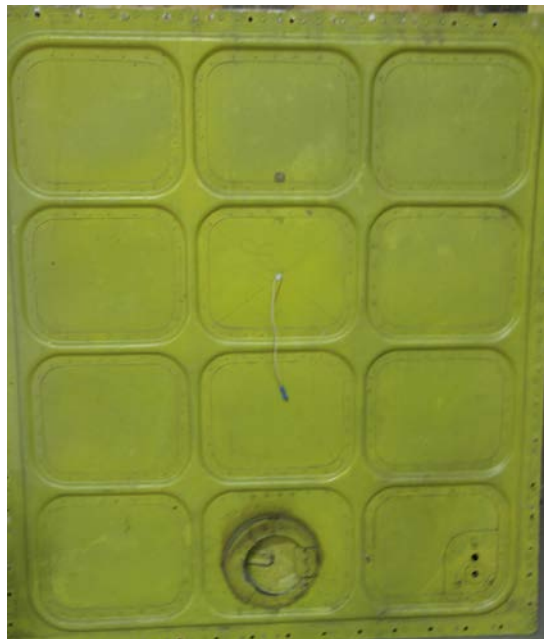
A part of an aircraft structure was investigated. It was an aluminium riveted panel (thickness: 0.7 mm) that is a part of PZL-101 "Gawron" wing (Figure 1). A piezoelectric sensor (material: SONOX P502, diameter: 10 mm, thickness: 0.5 mm) was placed at the middle of one of the sections. The sensors was used to excite elastic waves. The excitation signal was a tone burst with 5 cycles of sine (100 kHz, 100 V). Measurements were divided into three cases. Firstly, a reference panel (without additional mass) was considered. Secondly, additional mass – a coin (diameter: 15.5 mm, weight: 1.5 g) was placed before the rivet lines 80 mm from the piezoelectric sensor (position 1 in Fig. 2). Thirdly, the mass was placed behind the rivet line 145 mm from the piezoelectric sensor (position 2 in Fig. 2). The placement of sensor and additional mass was schematically presented in Figure 2.

Figure 1. Investigated aircraft panel.

The measurements were conducted using scanning laser vibrometer (Polytec PSV400). The measured surface was covered with retroreflective tape in order to enhance the signal level. The measured surface was the other than this shown in Figure 1. This means, that neither the presence of sensor nor additional mass influenced the measurements. For each case 94149 measurement points were used. The mean distance between two neighboring points were 1.6 mm, ensuring high spatial sampling of the wave field.

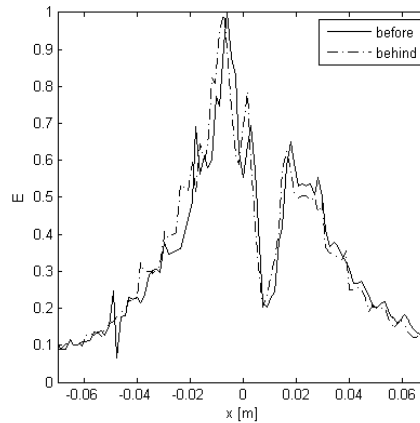
Figure 9. Energy distribution along a horizontal line 150 mm away from the sensor. This distance corresponds to a discontinuity placed behind the rivet lines.

As one can notice for both cases (additional mass before and behind the rivet lines) the presence of additional mass did not influence the reading and the result follows the same trend. In the second step the points lying 80 mm away from the sensor were picked. This distance corresponds to the mass placed before the rivet line. This time an energy drop was observed in comparison to the case without the mass (Figure 8). The energy drop is around $x=0$ which correspond to horizontal position of the sensor and the additional mass. The variation in energy is a clear indicator of damage presence. In the third step of investigation the distance corresponding to the mass placed behind rivet lines (150 mm away from the sensor) was considered. In both cases the energy distribution along a horizontal line follows the same trend (Figure 9). It appears that the wave energy after propagating through the rivet lines is too weak to indicate the presence of the discontinuity.
