Damage Detection by Load Path Changes in Reinforced Composite Panels Using Local FBGS and Distributed Sensing

M. FRÖVEL¹, E. DEL OLMO², A. FERNÁNDEZ³, F. QUERO⁴,
G. CARRIÓN¹, J. M. PINTADO¹ and A. GÜEMES³

A SHM technique based on the load path changes has been used to identify debondings in two blades stiffened space grade composite panels. These panels have been instrumented with Fiber Bragg Gratings Sensors, FBGS. The egress of the optical fiber from these panels was made in one panel with pig tails and in the other with embedded optical connectors. Additionally to the local FBGSs, distributed sensors based on the Rayleigh backscattering effect have been embedded in the skin of the second panel. This sensor technique assesses the strains along the entire optical fiber length not only in the stiffeners but also in the skin of the panel. Both techniques have been compared during compression tests of the panels and their ability to detect damage has been evaluated.

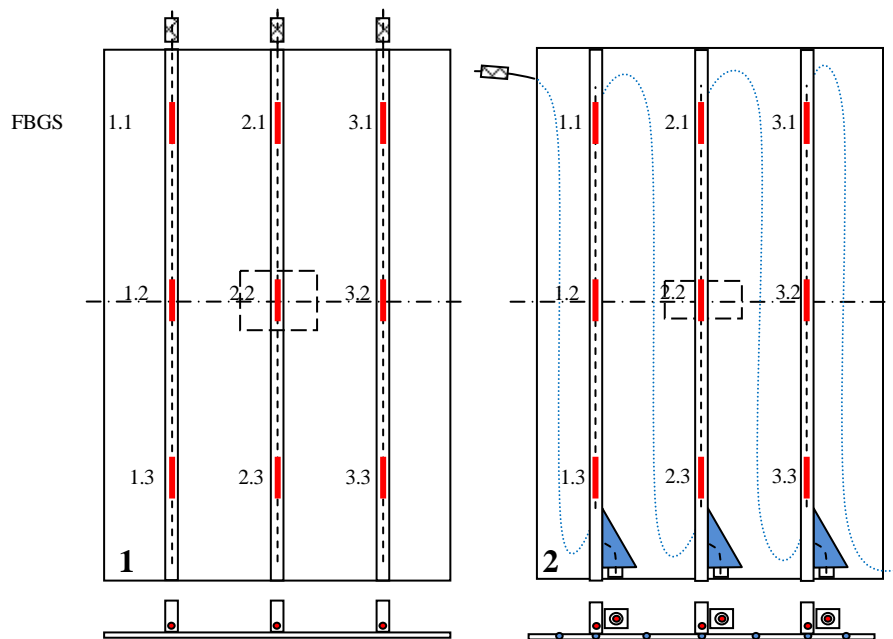
Figure 1. Sketches of the manufactured panels. The interrupted lines represent the optical fibers embedded in the stiffener webs. The fat lines are the FBGSs. The interrupted square in the central stiffener represents the artificial debonding. Left: Panel 1. Right: Panel 2 with embedded optical connectors in the stiffener webs and the distributed sensor fiber embedded in the skin (dotted lone).

Two different specimens have been manufactured that are representative for structures made in the automatic fiber placement process, although they have been manufactured in this case by hand lay-up. The specimens are stiffened panels with UD reinforced stiffeners and a quasi-isotropic, c.i., skins layup. The used material is high stiffness fiber and out of autoclave curing resin system. The dimensions of panel 1 and 2 are: 562 x 300mm/ 570 x 300mm, and stiffeners of 4,5mm 6,7mm in width and 15mm /12 mm in height with 85 mm space between stiffeners in both panels. The specimens have been instrumented with three FBGS in each of the three stiffener webs. The egress of the optical fiber from these panels was made in panel 1 with pig tails and in the other with embedded optical small form factor connectors. Panel 2 has been instrumented additionally with embedded optical fibers without sensors to apply the distributed sensing technique. The FBGSs and the optical fiber without sensors are Ormocer coated high strength fibers made by the draw tower process and commercialized from FBGS Technologies company [5, 6]. The excellent performance and highly stable sensitivity of these sensors has been demonstrated before in static and fatigue tests in a wide temperature range from -100°C to 160°C [7].

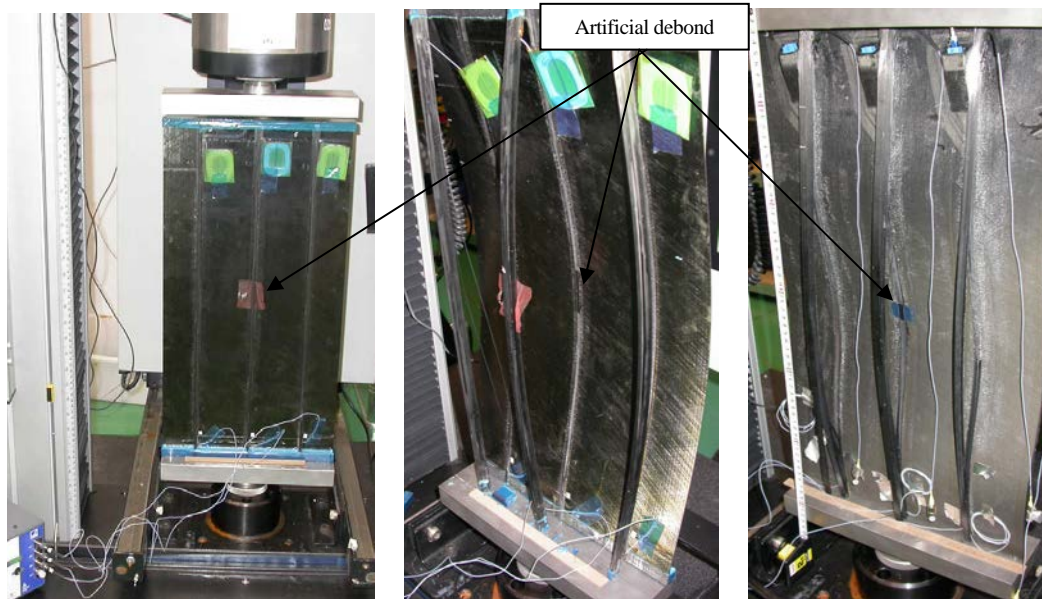
Figure 2. Left: Panel 1 in test rig. Mid.: Panel 1 after breakage. Right: Panel 2 after breakage. Both broken panels are still under a small compression load.

The panels have been tested in static compression tests between parallel, non articulated plates until break, figure 2 left. The strains of the panels have been measured with two different equipments. In the case of the FBGS, a Si405 lecture equipment from HBM has been used and for the distributed sensors an OBR4600 sensing equipment from LUNA Innovations, [9, 10]. The test load has been applied in steps of 2 kN with 40s of plateau where the measurements of the distributed sensors have been taken. The measurements in the plateaus are the results of the distributed sensors.

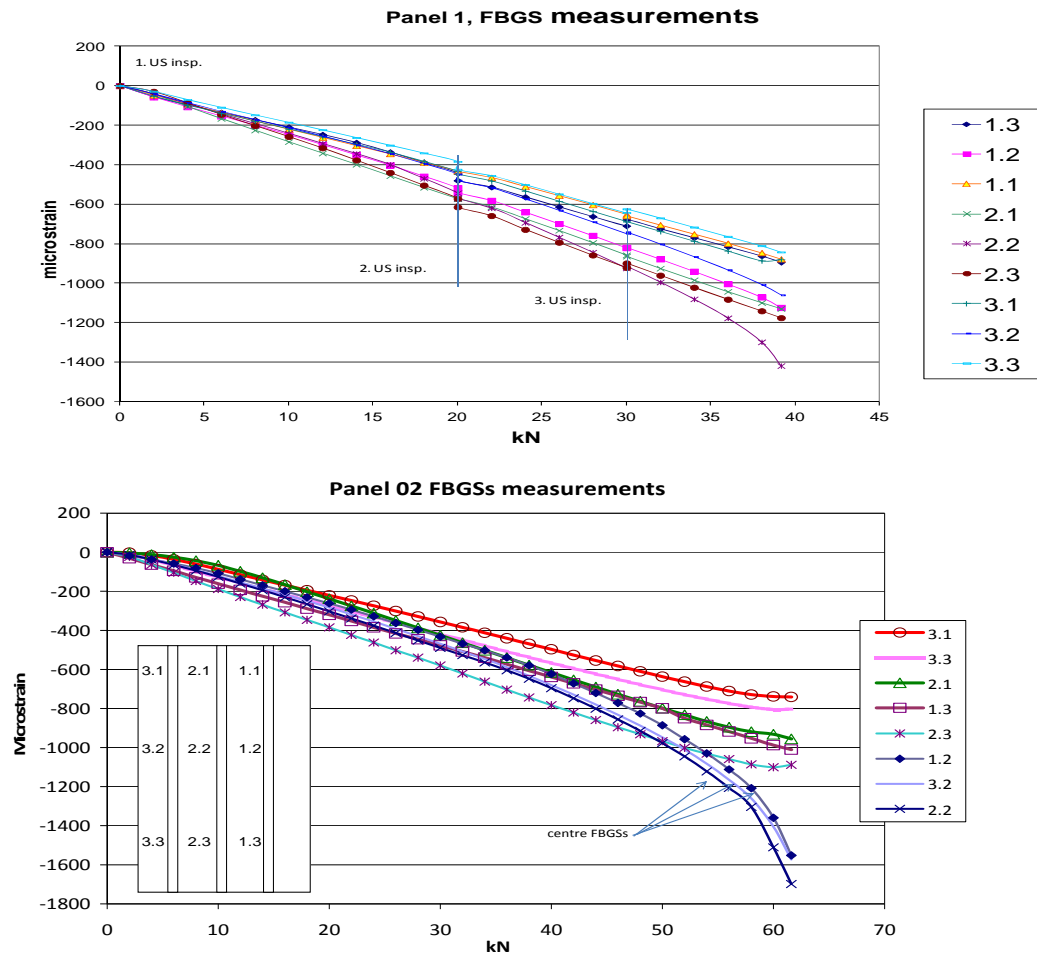
Figure 3. Strain measurements with FBGS embedded in three positions along all three stiffeners in the same position. UP: Panel 1. DOWNn: Panel 2.

The strain measurements of the FBGSs show in both panels a continuous deformation with increasing load, figure 3. In both panels a general change in the strain distribution can be noticed at elevated loads provoked by the buckling of the skins. No clear change has been noticed along the tests in the strain distribution between the central stiffeners of both panels to their adjacent stiffeners, which could have been an indicator for an increment of the debonding size. The ruptures of both panels were catastrophic with an instantaneous debonding of all the three stiffeners, figure 2 mid and right. In the case of panel 1, a C-scan inspection has been performed not only before testing like in both panels, but also at 50% and 75% of the final rupture load. No increment of the artificial debond has been detected in these inspections. It was expected before the tests that a graduated increment of the central stiffener delamination would occur or that at least only the central stiffener would debond, but the tests of both specimens showed different results. It seems to be possible to state that in this configuration of relative wide stiffeners made of high modulus fiber, the rupture of the panels is catastrophic and no gradual delamination or debonding can be expected. These results are also congruent with the results of the

panel tested in [4] were a wide area of the grid stiffeners delaminated from the skin and with the results of the C-scan inspections of panel 1 that didn't show any increment of the debonding size. Due to this instantaneous rupture without any detectable debonding increase prior to the total rupture, it can be stated that a damage monitoring of this kind of UD stiffened skin panels with embedded FBGS is very difficult.

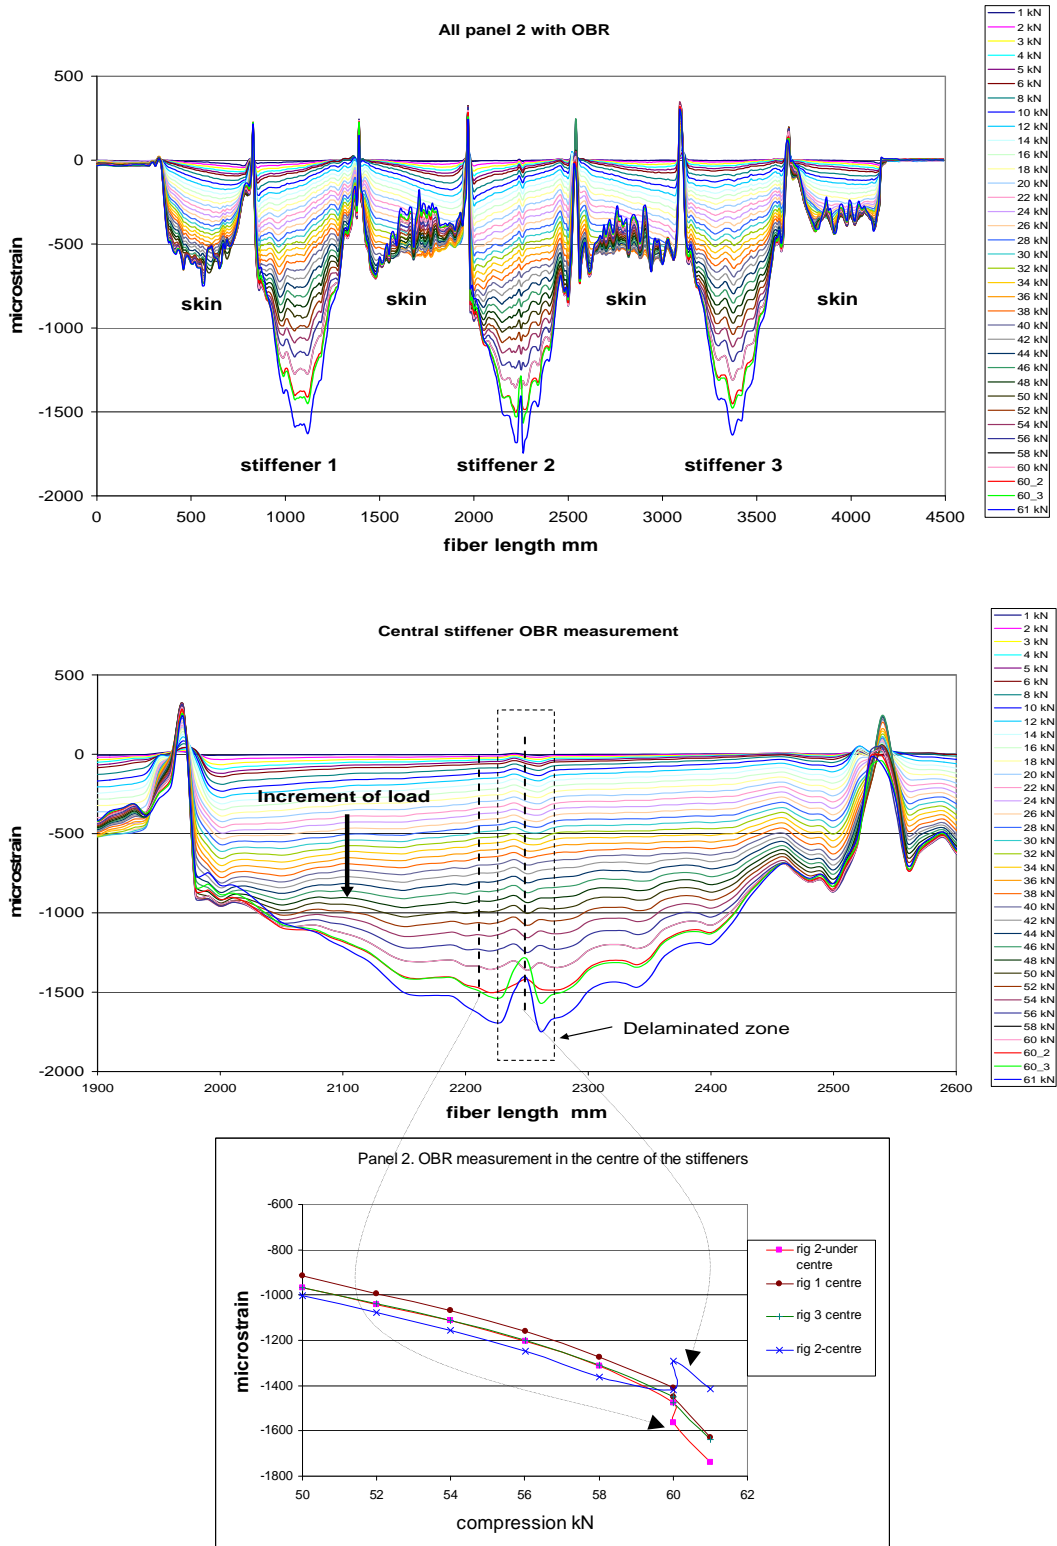
Figure 4. Mechanical response of panel 2 in compression test before breakage. UP: Distributed sensing strain measurement of the entire panel. MID.: Details of the central stiffener. The delamination can be distinguished with incrementing load. DOWN: Detail close to breakage load. A bifurcation of both measurements of the central stiffener indicates the artificial debond of 25 mm.

In the case of panel 2, the distributed sensors showed a different result. In this case it was possible to detect the artificial debond when increasing load, figure 4 up. Due to the fact that all the fiber length is monitored and that the optical fiber was embedded in the skin of the panel, the debond zone could be detected. With increasing load the zone of the skin just under the debond is not able to transmit the strain as the rest of the skins that are bonded to the stiffeners. At high loads the skins under the delamination starts to buckle and the measured strain values near and just under the delamination show a clear bifurcation that is an indicator for the presence of a debond, figure 4 down. This result could only be achieved with a distributed sensing technique, because it is necessary to compare the strains of small zones with each others. Measuring only in three points of the stiffener is not enough to identify a small delamination in these UD stiffened panels even if the FBGSs would have been embedded in the skin like the distributed sensing optical fiber.

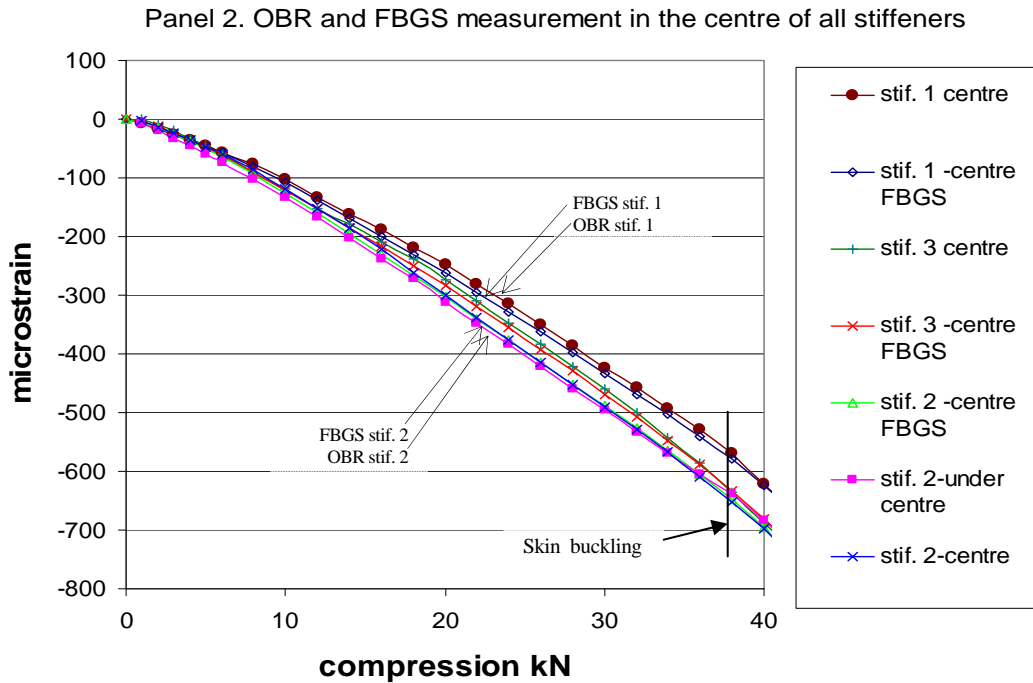
Figure 5. Detail of the strain measurements of the FBGSs and the distributed sensors in panel 2 in the centre of the three stiffeners.

A very good agreement has been obtained between the strain measurements of the FBGSs and the distributed sensing, figure 5. The strain values are almost the same until the skin of the panel buckles and slightly different values are measured in both types of sensors. These differences can be explained by different load states in the skin, were the distributed sensing fiber is embedded and the stiffeners were the FBGSs are embedded.
