Active Thermography Method for Delamination Detection and Localisation in Composite Structures

ABSTRACT

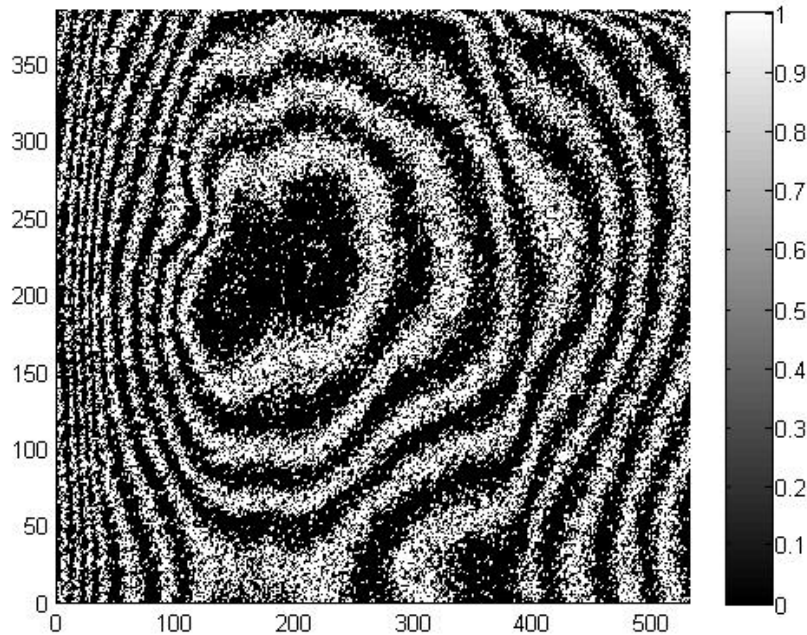
In the first step of the experiment one delamination (denoted as D_1 - Figure 1) was made. Figure 4 presents map of differences between two maps containing processed signals from infrared camera. The optical source location is visible in the map. Unfortunately the delamination slightly influenced the heat distribution process. A curvature of gradient lines is visible in its location, but similar curvature can be notice in other parts of the sample. The problem with detection of the particular delamination was strongly related to heating source location. A part of the delamination was located on a part of a sample that was not heated at the instant of turning on the heating source (halogen lamp). So, the delamination part hid in a shadow in a border part of the investigated sample, while the second half of it was located in the hotter part of the sample.

Figure 4. Maps of differences between two processed frames M' from the infrared camera for one delamination.
