# Health Monitoring of a Weight Efficient Lattice Spacecraft Structural Element with FBGS Sensors

A weight efficient lattice cylinder of high modulus carbon fiber has been manufactured by EADS CASA Espacio using a new cost efficient fiber placement layering technology and curing process. The open iso-grid structure is formed of composite lattice bars of unidirectional fiber direction where the half of these bars have been instrumented with fibre Bragg grating sensors, FBGSs. These sensors measured the structural strain and the integrity of the structure during static tests conducted until rupture.

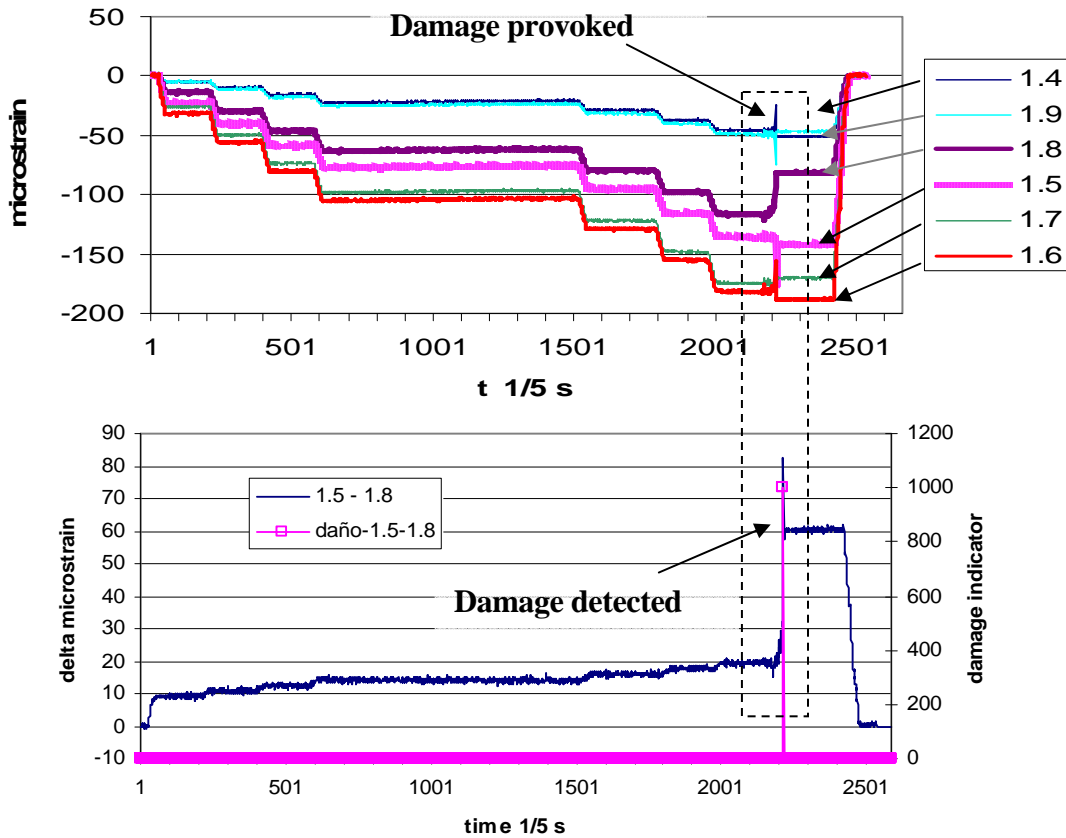
Figure 4. Test result of the cut N° 3 two layers above sensor 1.8. UP: Strain measured in the six FBGS of the panel. Down: The diagram shows the strain difference between FBGS 1.8 and FBGS 1.5 and the moment when the damage have been detected.

The lattice cylinder failed in catastrophic rupture and many bars and nodes have been broken at the same time. The mayor parts of the ruptures have occurred very near to the bonded sensors and the ruptures of the structure have been detected very clear. The following tests are focused on to study how sensible the sensors are to detect damage far from the sensors and when only one bar breaks. To study this behavior three sectors of  $45^\circ$  to  $60^\circ$  of the cylinder perimeter have been cut from the damaged lattice structure and the broken or delaminated bars and nodes have been repaired so that they are able to carry again load in the following tests. The sectors have been loaded in compression step loading until about 100 to 250 microstrain have been measured in the central monitored grids, figure 3 left. At maximum load, controlled damages have been introduced by cutting bars with a small radial disc cutter. The strain redistributed very fast into the adjacent grids when the grid was cut and a jump of the strain could be measured in the sensors corresponding to the bar that has been cut and also in the instrumented adjacent bars, figure 4.

To identify if a jump in the strain values is produced by damage or by a fast step load of the structure without damage, the results of all the sensors need to be compared. If a jump in the strain values is provoked by damage, sensors near to the damage show a more pronounced strain jump than sensors far from the damage. Applying this technique, the introduced damages have been detected in the tested sectors until four layers far from a sensor and this not only when the cut was in the same bar but even when it was in the adjacent bar. The strain jump between compared sensors at the maximum observable distance of four layers (about 330 mm) was  $6\mu\epsilon$  that was clearly above the noise threshold of the used equipment. The strain jump increases when the cut was nearer to the sensor being about  $10\mu\epsilon$ ,  $30\mu\epsilon$  and  $50\mu\epsilon$ , in the cut of the same bar of FBGS 1.8, three, two and one layer far from the sensor 1.8, respectively. Cuts in perpendicular bars were detectable two to three layers far from the sensor with a strain jump of about  $10\mu\epsilon$  and  $6\mu\epsilon$ , respectively. Horizontal bars cut at 4 and 3 layers above the sensor show a strain jump of  $6\mu\epsilon$  and  $20\mu\epsilon$ , respectively.
