# **Comparison of Lamb Wave Interaction with High- and Low-Cycle Fatigue Cracks in Aluminum Plates**

## C. T. OWENS, E. D. SWENSON, A. GOSHAL and J. T. AYERS

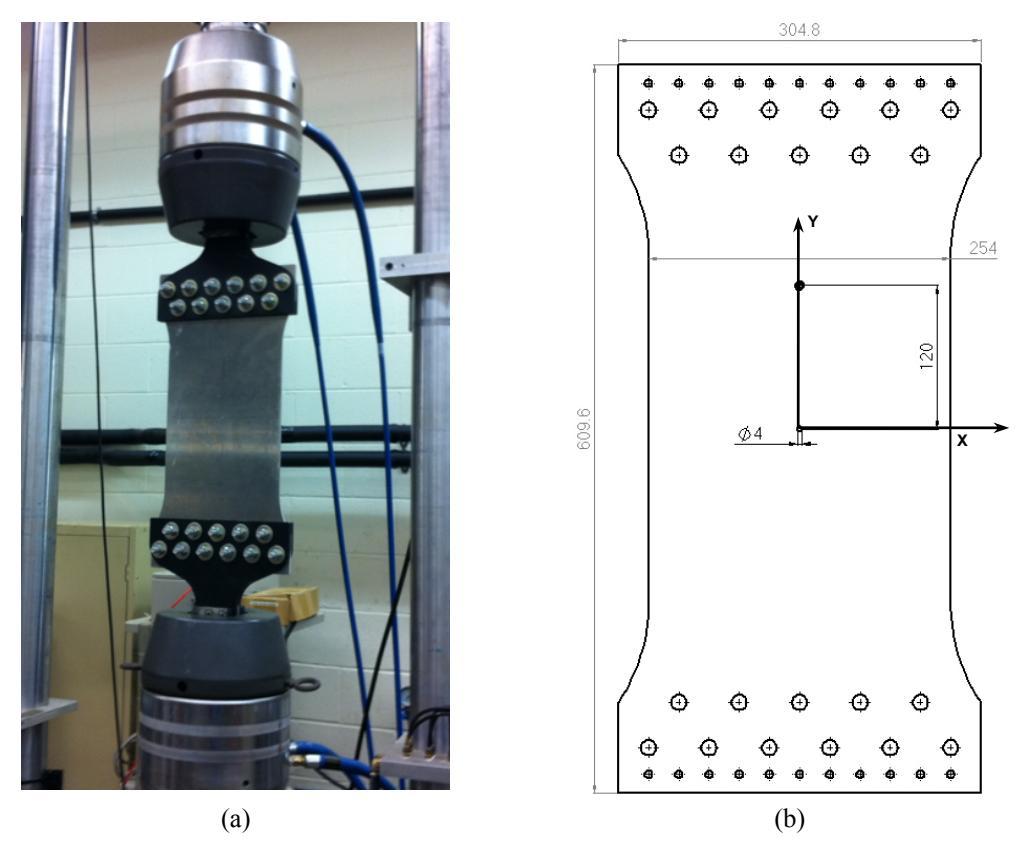
Figure 1. (a) Dogbone specimen in MTS, (b) Dogbone Layout showing transducer location.

Test specimens were 610 mm long by 305 mm wide by 3.175 mm thick 6061-T6 aluminum plates cut into a "dogbone." Test section width was 254 mm. A 4 mm diameter hole was drilled in the center of each specimen to represent a typical fastener hole and a partial depth notch (approximately 1 mm in length on either side of the hole) was etched with an Epilog FiberMark laser in order to facilitate fatigue crack growth. Two test specimens were prepared, each mounted in a set of mild steel grips using 12.7 mm diameter grade 8 bolts and loaded in a 500 kN Material Test Systems uniaxial fatigue test machine (Fig. 1(a)).

Both test articles were subjected to constant amplitude sinusoidal loading and developed cracks of approximately the same total length. Specific loading and crack length parameters are given in Table 1. Images of the cracks are shown in Figure 2 (fluorescent penetrant was used to improve crack visibility, which results in minor surface scratches appearing as short vertical lines). The XY axis origin was located at the center of the plates. A single 6.35 mm diameter by 0.254 mm thick PZT transducer was bonded to each plate using M-Bond 200 adhesive at (x,y) coordinates of (0,120 mm) and used for wave excitation (Fig. 1(b)).

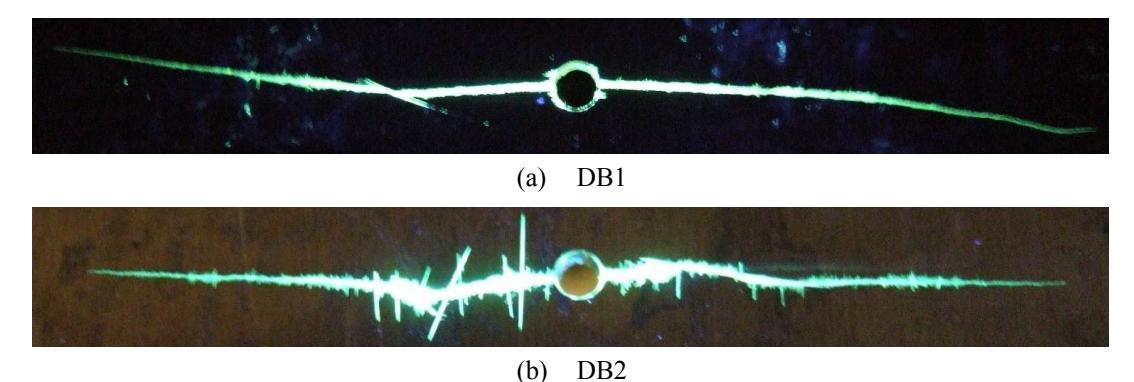
Figure 2. (a) High- and (b) low-cycle fatigue cracks.

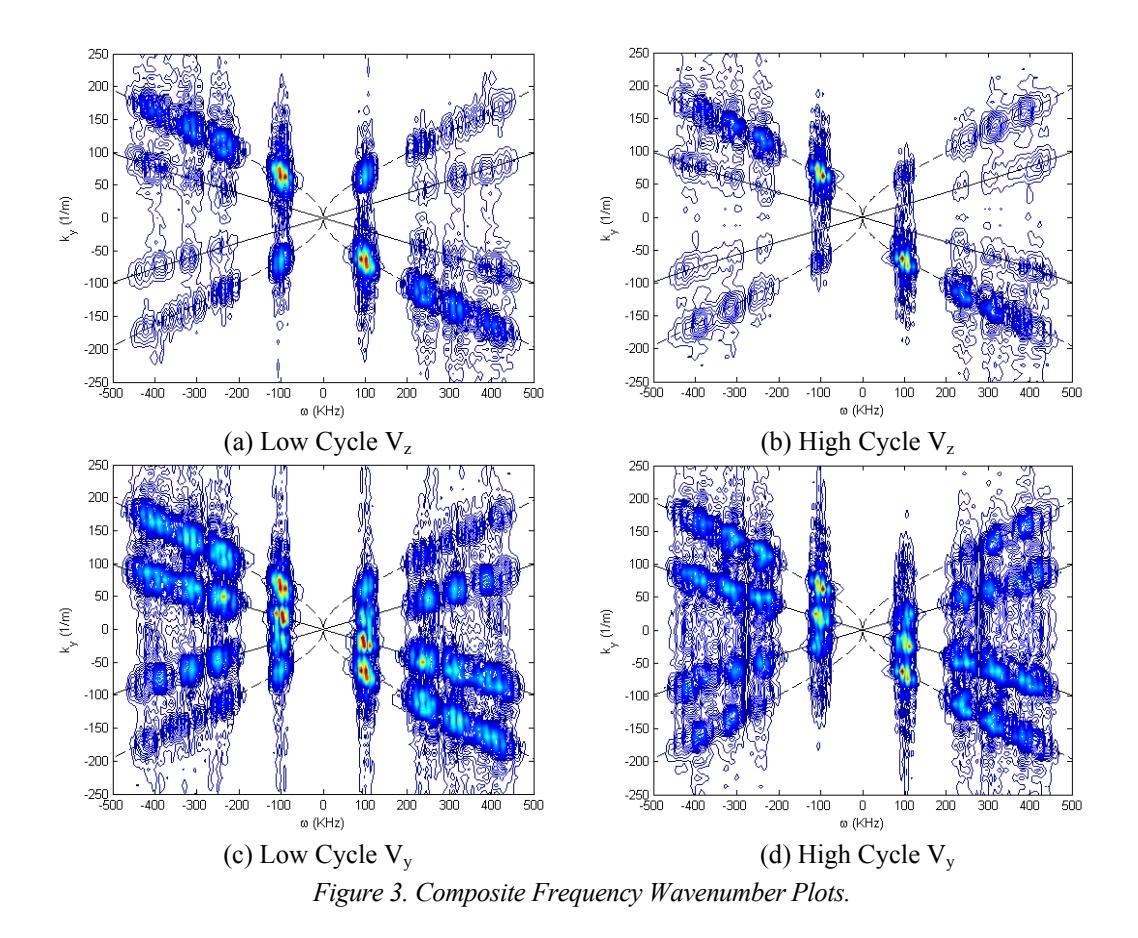
Composite frequency-wavenumber contour plots were generated using all scan points in the grid. Figure 3 includes plots for both out-of-plane  $(V_z)$  and in-plane  $(V_y)$  velocity components across all excitation frequencies for each test article. Analytical dispersion curves for both  $S_0$  and  $A_0$  wave modes are included. Comparing the high- vs. low-cycle data, the low-cycle plots appear to have higher peaks in the quadrants representing reflected signals (positive  $k_y$ ). However, the most noticeable difference between plots is the change in  $S_0$  mode amplitude when comparing in-plane and out-of-plane velocity data. Because symmetric modes are predominantly an in-plane phenomenon (longitudinal waves), this result is expected.

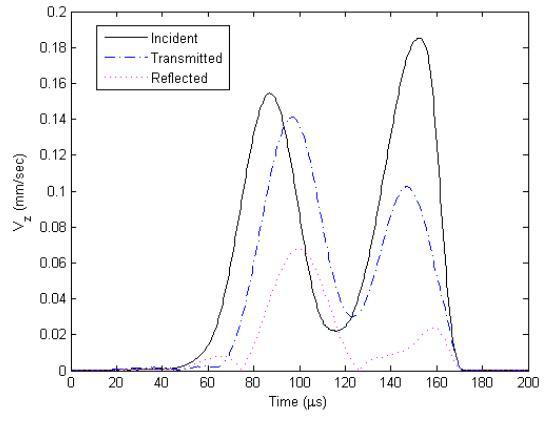
Figure 4. Hilbert Transform of a Scan Point at 100 KHz Excitation.

The data were filtered (windowed by quadrant) and transformed back to the time-spatial domain. The reflection and transmission coefficients (RC and TC) were calculated via the Hilbert transform following a technique presented by Lu, *et al* [9, 10]. The filtered data from four lines of scan points (each parallel to the y-axis but at a different x-coordinate value) were processed via the Hilbert transform, the absolute value of which represents the time-varying magnitude envelope of the velocity time signal (Fig. 4). The maximum values of the different wave components were averaged along each line of data, and the RC and TC were calculated as ratios. The results are presented in Figure 5.

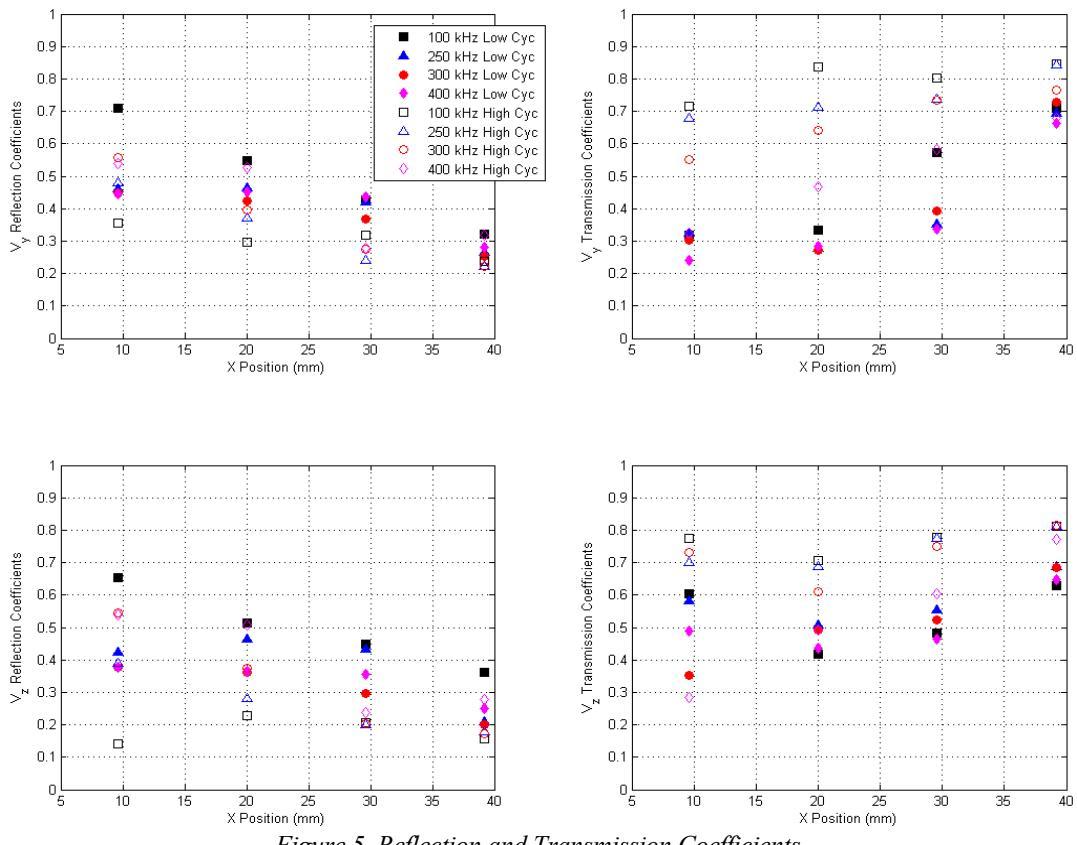
Figure 5. Reflection and Transmission Coefficients.

In general, the RC were highest near the center of both cracks and decreased towards the crack tips. RC also tended to decrease with increasing excitation frequency, though additional data is required to determine how well these factors are correlated. As would be expected, trends for TC were in the opposite direction of RC. RC for the low-cycle crack were consistently higher than those of the high-cycle crack. Based on wave field images of both test articles, it appears the center portion of the crack in DB2 (low-cycle test article) may be slightly open (Fig. 6), and a partially open crack would be expected to reflect more wave energy than a similar closed crack.

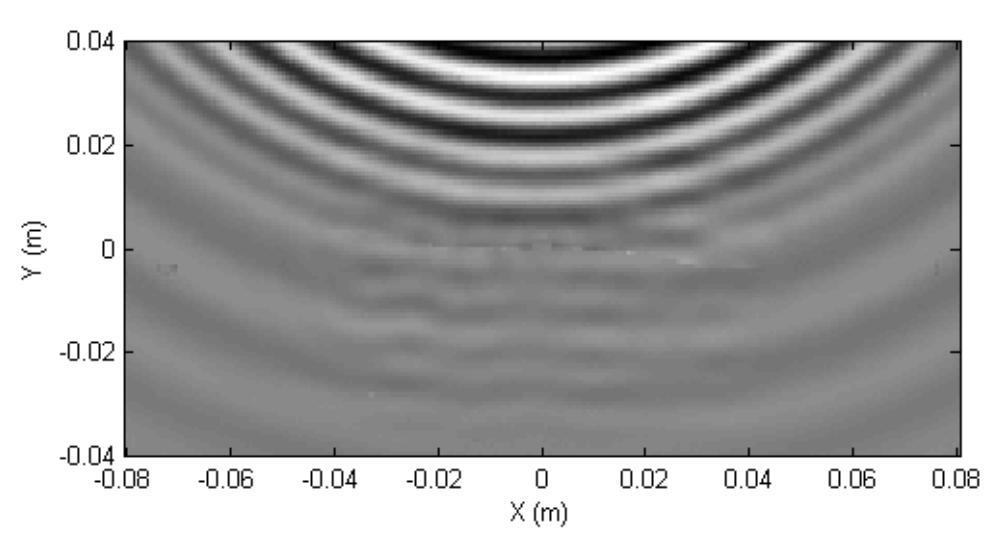
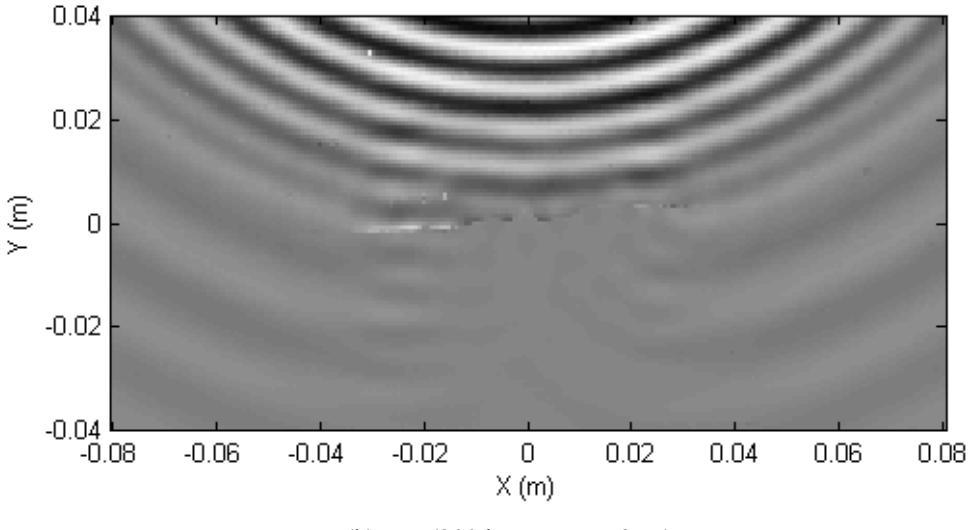
(a)  $V_z$  (300 kHz excitation, t = 55.9 µs)

(b) 
$$V_z$$
 (300 kHz, t = 55.9 µs)

Figure 6. Lamb wave interaction with (a) high- and (b) low-cycle fatigue cracks.
