Evaluation of Flight Data from an Airworthy Structural Health Monitoring System Integrally Embedded in an Unmanned Air Vehicle

ABSTRACT

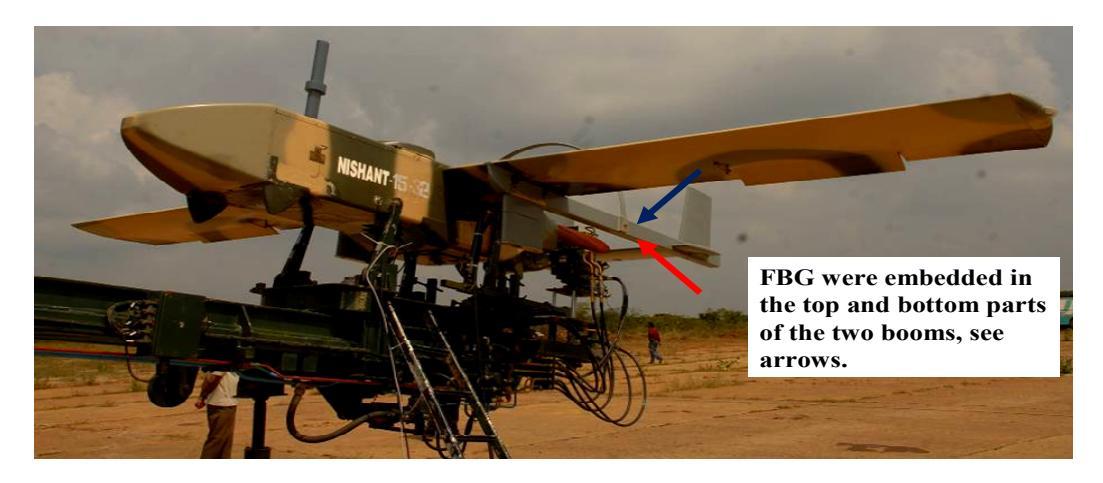
Figure 1. The Nishant UAV on the launcher.

The Nishant UAV (Figure 1), designed and manufactured in India by ADE was selected as the test-bed for the evaluation of this HUMS concept. Each of the two tail booms of the Nishant is a composite structure made of two thin wall "C" section channels, riveted together to form a close rectangular beam. The back the booms hold the empennage, comprising a horizontal tail (with elevator) and two vertical tails. The thickness of the composite boom walls is optimized for both strength and stiffness [2].

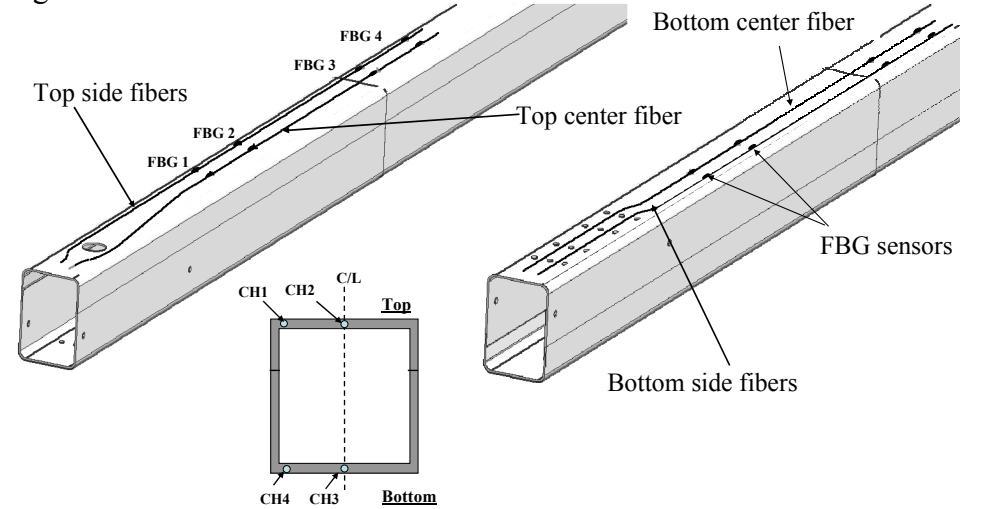
Figure 2. Boom general layout and routing of the embedded optical fibers inside the boom. 16 FBGs were located at points of interest.

The boom is basically a cantilever beam with a relatively large mass at the back end. The main boom loading conditions are vertical and horizontal bending. In order to track the expected loading conditions, two Fibers were embedded at the centers of the boom ("center Fibers", CH2, CH3 in Figure 2) and another two Fibers were embedded near the corners ("side Fibers", CH1, CH4 in Figure 2). Four FBG sensors were imprinted on each Fiber. Thus, each critical section of the boom is monitored by four FBGs: two on top and two on the bottom (Figure 2). For such sensing net arrangement, the two centre Fibers are only sensitive to vertical bending while the side Fibers are sensitive to the vertical bending in a similar manner as the central ones, but will also react to horizontal bending. Since no tension loading is applied on the boom, the vertical bending will introduce theoretically identical but opposite strains in the top and bottom Fibers. The two side Fibers are on the same side with respect to the center line. Hence, the horizontal bending will induces similar strains on both side Fibers, in addition to the vertical bending contribution. In the reported test flight only the center Fibers of both booms were tracked, enabling tracking of the vertical bending of the two booms.

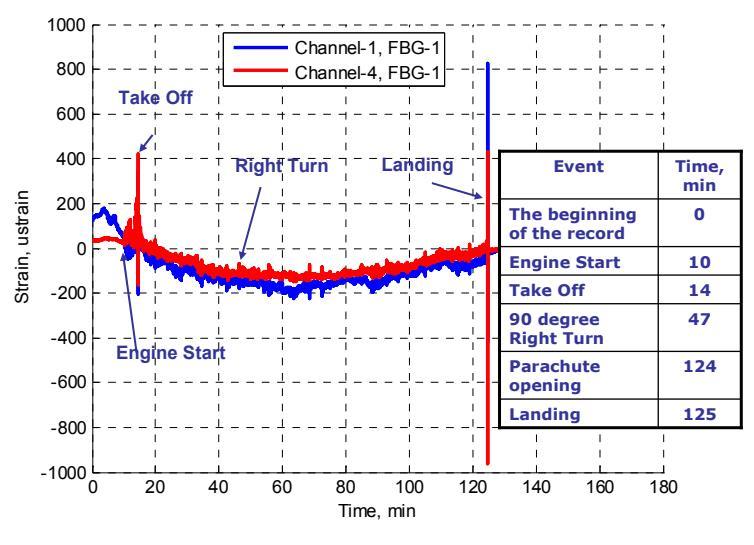
Figure 3. Typical FBG readings during flight.

The Nishant UAV, equipped with the airworthy HUMS system, was flown at Kolar air field near Bangalore, India. It was demonstrated that the flight worthy interrogation system, integrated into the Nishant UAV, withstood all flight conditions including a catapulted launch, flight maneuvers and parachute landing. Measured readings (in terms of the optical strain: $\Delta\lambda_B/\lambda_B$, where $\Delta\lambda_B$ is the FBG strain-induced wavelength shift from its initial value of λ_B) of a pair FBG1 gratings (Figure 2), one on top center and the other on bottom center, are shown in Figure 3 for the duration of the entire flight.

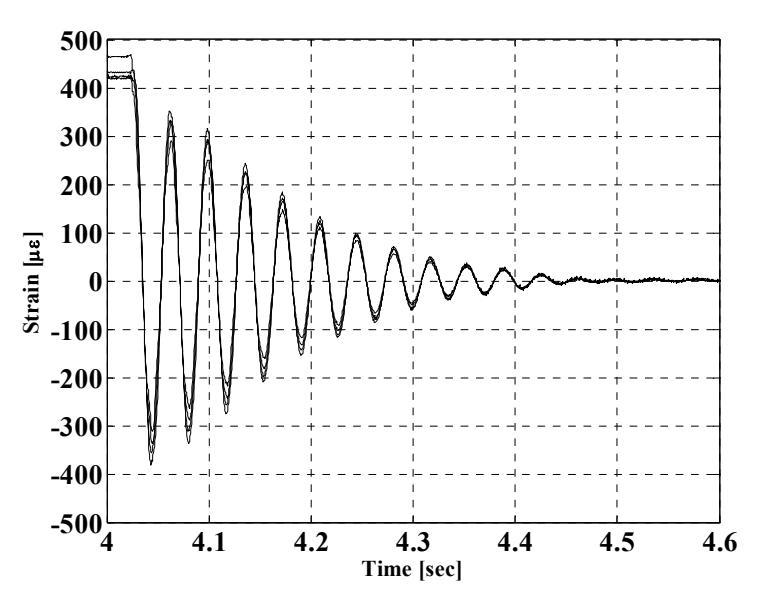
Figure 4. FBG readings during ground impact at the tail attachment.

The basic concept for tracking the structural integrity of the booms is based on cross correlation between normalized sensors [3, 4]. Since the boom itself is light with respect to the weight of the horizontal and vertical tails, the first vibrational bending mode is dominant. This is especially true for the case of ground touch-down impact during UAV landing. FBG readings during ground tail impact test of the instrumented boom are presented in Figure 4.

In this test a 60Kg weight, attached to the boom at its end, was suddenly released. It is clearly seen that all sensor reacted in a similar manner, though the amplitude is not the same. It is concluded that in this test only the first vibration mode was excited since no phase shift between the sensors is observed.

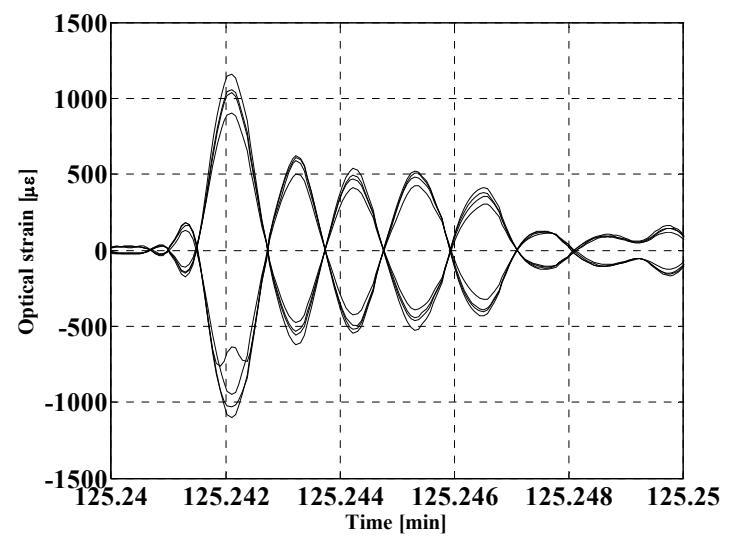
Figure 5. FBG readings during landing.

An interesting test case is shown in Fig. 5. Taken during the actual touch-down, it describes readings from all eight center FBGs of one of the booms. All sensors are clearly in phase, indicating first bending mode vibration behavior at a frequency of f=7.4Hz. Note the small glitch near time 125.242 min, which may indicate a small elastic buckling. How can such a rare incidence be identified in the more than 7GByte of collected data?

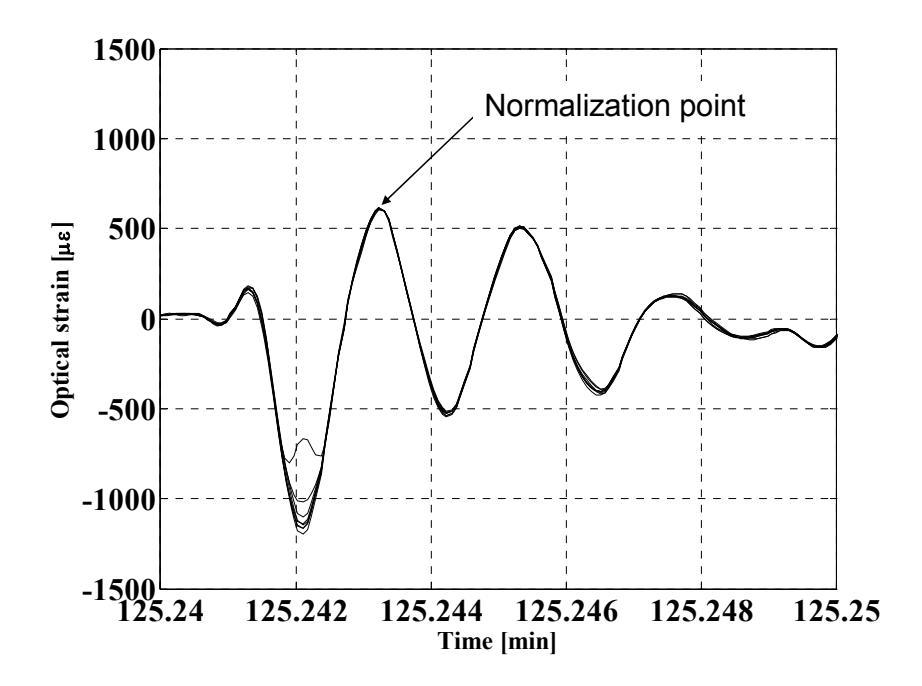
Figure 6. Normalized FBG readings during landing.

In view of the similarity among the different sensors, a load and damage tracking algorithm was constructed, based on the detection of deviations from the expected modal behavior. The need to handle large data, obtained by many sensors also calls for means to reduce the order of the problem. In the current case, where only the deviations from the first mode of vertical bending are of interest, the following approach was taken. The first step was to decimate the data by down sampling to 250Hz, followed by normalizing all sensors amplitudes to have the same reading a moderate loading level (at 125.243 Min.). To compensate for the 180° phase shift between the top and bottom sensors, the readings from the latter were inverted. The normalized sensors data is shown in Figure 6. The final step is to plot all sensors readings (normalized and down sampled at 250Hz) as a function of one sensor to get the cross correlation function. Thus, Figure 7 plots the instantaneous normalized readings from seven FBGs as a function of simultaneous readings from the eighth one. Had only pure linear first mode vibration behavior existed, all normalized sensors data would have fallen on the same unit slope straight line. This is generally true for the data of Figure 7 with one important clear exception near -800 microstrains. This deviation is a direct consequence of the above-mentioned glitch in Figure 3, this time automatically detected through an efficient reduction of the order of the problem to a single two dimensional chart, which presents data from all sensors during as prescribed time period. Finally, since *all* deviating points were found to belong to a single incidence, it is safely concluded the boom fully recovers and remains intact!

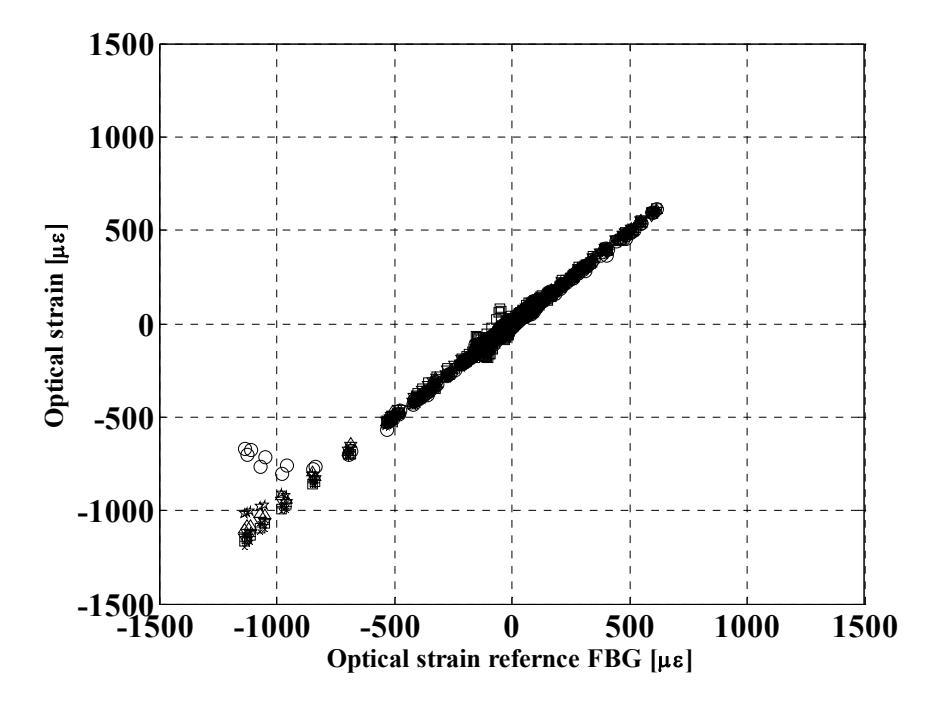
Figure 7. Cross correlation of FBG readings.
